DEPARTMENT OF TRANSPORTATION

Quality Assurance and Source Inspection

Contract #: 04-0120F4Cty: SF/ALA Rte: 80 PM: 13.2/13.9File #: 1.28**WELDING INSPECTION REPORT****Resident Engineer:**Siegenthaler, Peter**Address:** 333 Burma Road**City:** Oakland, CA 94607**Report No:** WIR-025377**Date Inspected:** 29-Jul-2011**Project Name:** SAS Superstructure**OSM Arrival Time:** 700**Prime Contractor:** American Bridge/Fluor Enterprises, a JV**OSM Departure Time:** 1530**Contractor:** American Bridge/Fluor Enterprises, a JV**Location:** Job Site**CWI Name:** See Below**CWI Present:** Yes No**Inspected CWI report:** Yes No N/A**Rod Oven in Use:** Yes No N/A**Electrode to specification:** Yes No N/A**Weld Procedures Followed:** Yes No N/A**Qualified Welders:** Yes No N/A**Verified Joint Fit-up:** Yes No N/A**Approved Drawings:** Yes No N/A**Approved WPS:** Yes No N/A**Delayed / Cancelled:** Yes No N/A**Bridge No:** 34-0006**Component:** Orthotropic Box Girder**Summary of Items Observed:**

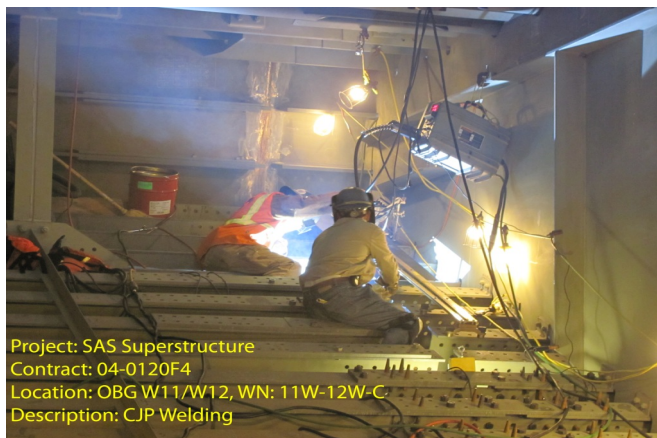
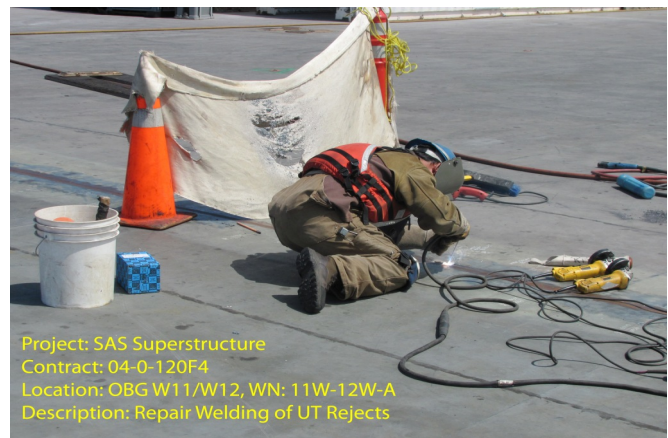
The welding was performed in the flat and horizontal positions utilizing the E71T-1 consumable. The welding parameters and surface temperatures were verified by the QC inspector's utilizing a Fluke 337 clamp meter to measure the electrical welding parameters and Tempil Heat Indicators for verifying the preheat and interpass temperatures. At the time of the observation no issues were noted by the QAI.

The digital photographs below illustrate some of the work observed during this scheduled work date.
